**United States Air Force
611th Air Support Group/
Civil Engineering Squadron**

Remedial Investigation and Feasibility Study

**Cape Lisburne Radar Installation,
Alaska**

ICF Technology Incorporated

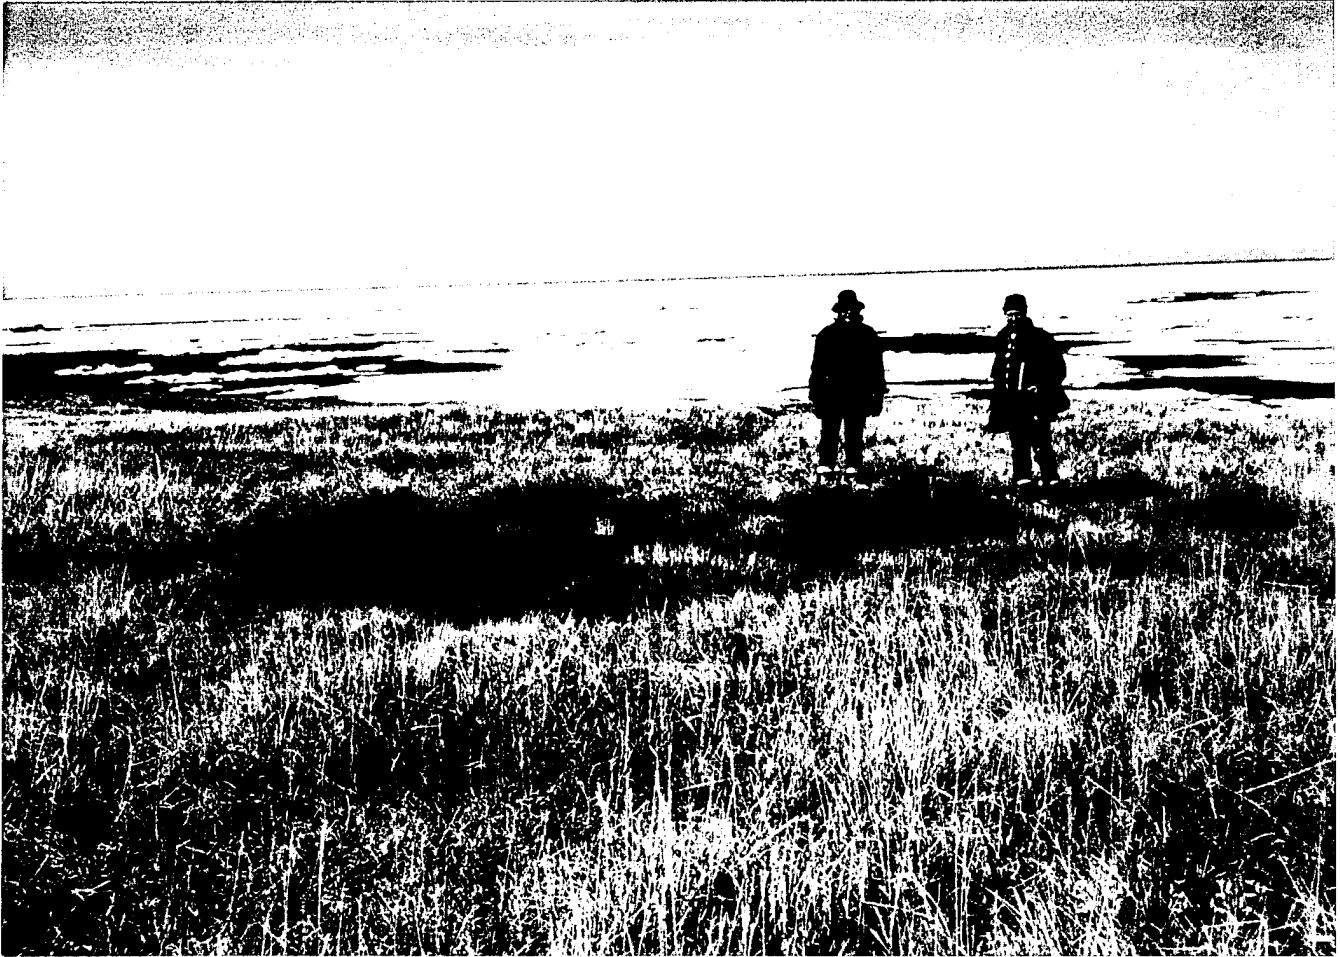
A view to the northwest of the buried drum area at the Landfill and Waste Accumulation Area (LF01) prior to Interim Remedial Actions (IRA) at the site. IRA actions at this site in May 1995 included excavation and containment of approximately 100 drums and associated contaminated soils.

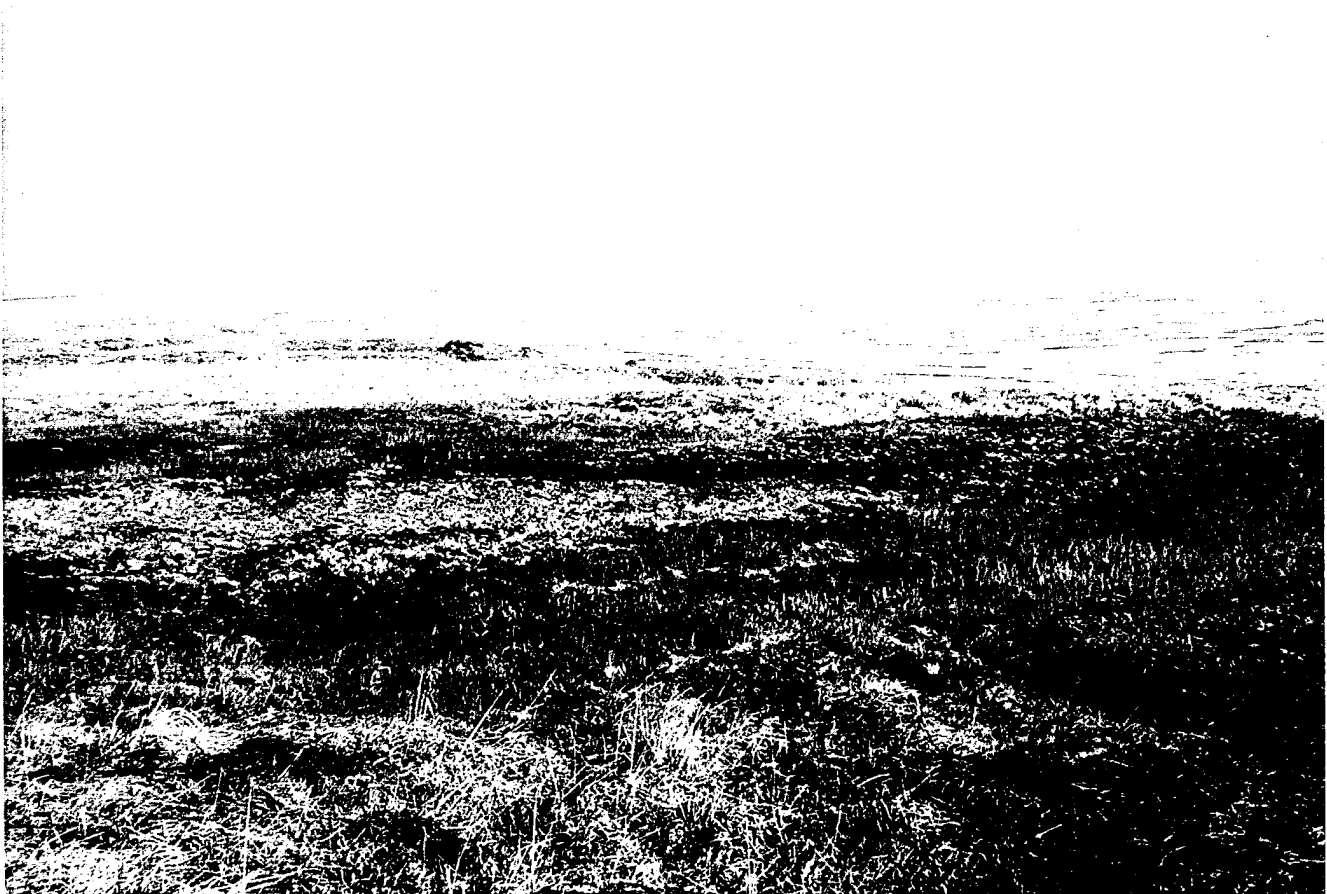
A view to the northwest of the buried drum area after excavation at the Landfill and Waste Accumulation Area (LF01). Clean gravel from the installation's quarry was used to backfill the excavation. The disturbed areas were seeded and fertilized as part of IRA activities.

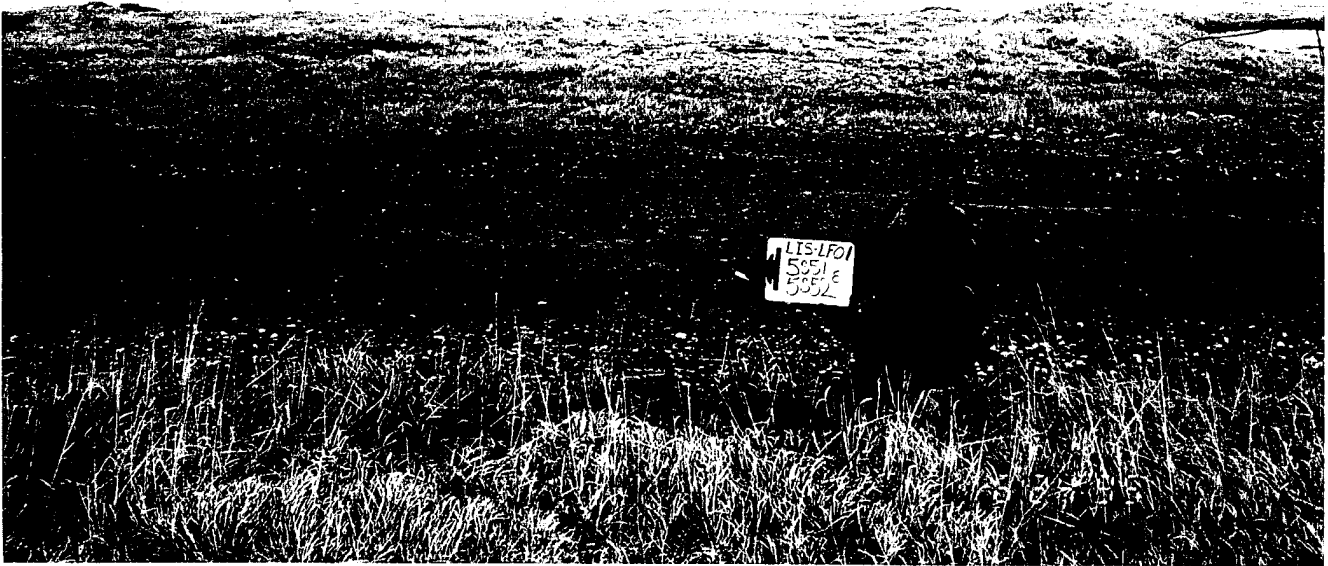
A view to the north of gravel covered area #1 at the Landfill and Waste Accumulation Area (LF01).

Offsite treatment/disposal is recommended as the alternative for remediation of the affected areas at the site (gravel covered areas #1 and #2 and soils in the containment cell). A complete

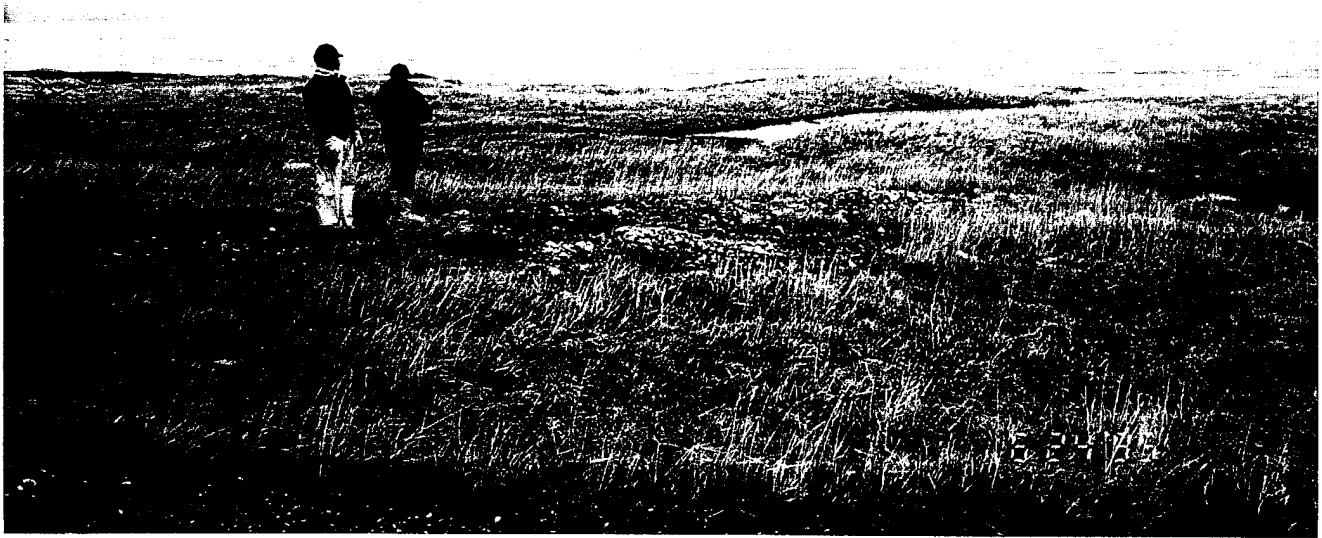
A view to the northwest of gravel covered area #2 at the Landfill and Waste Accumulation Area (LF01). The gravel covered area #1 is located in the middle left side of the photo.

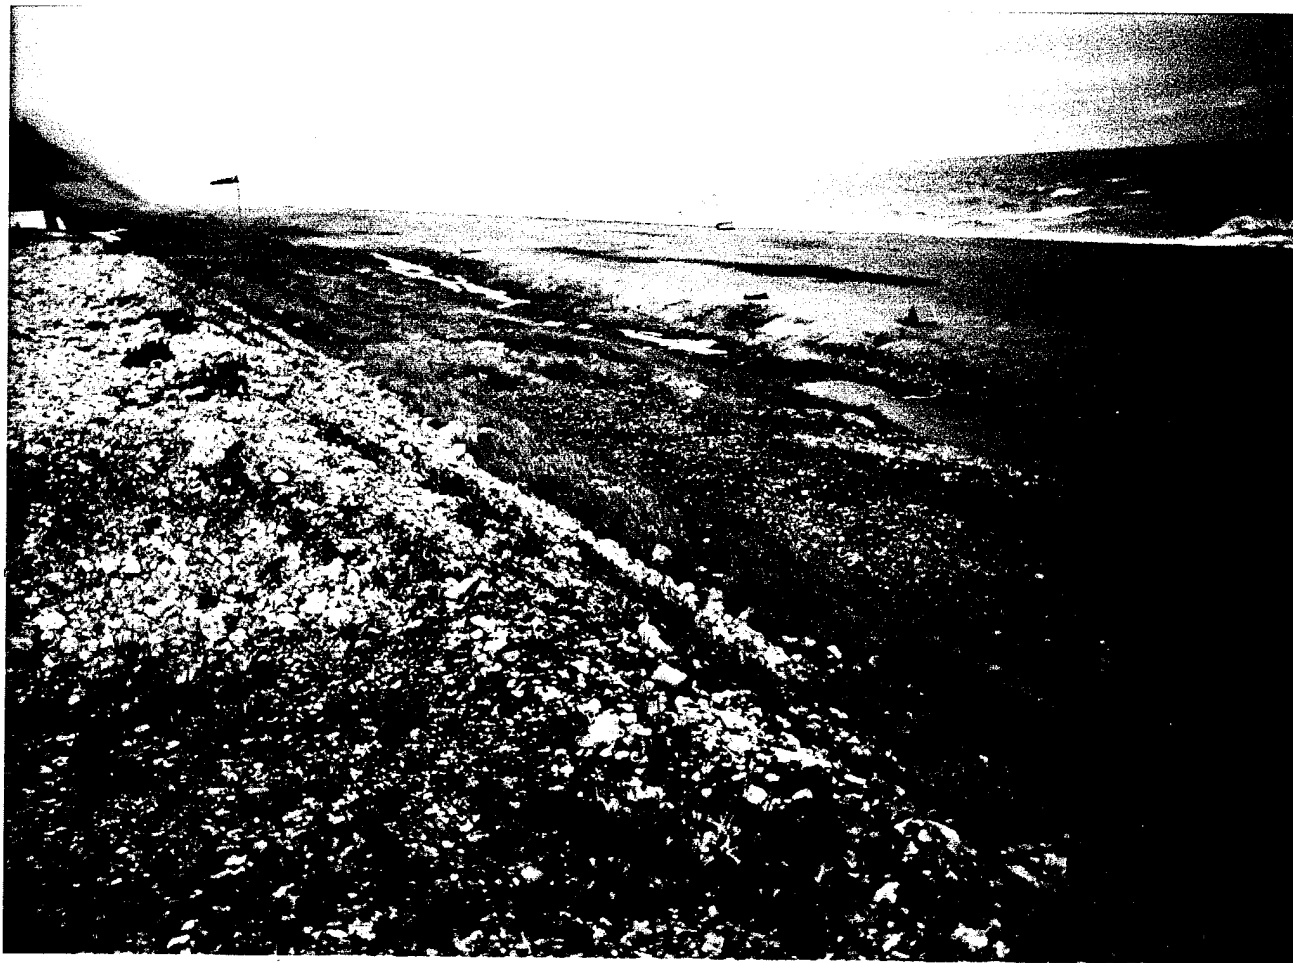
A view to the northeast of the Spill/Leak #3 (ST07) site. Part of the gravel berm surrounding the diesel tanks can be seen to the left.

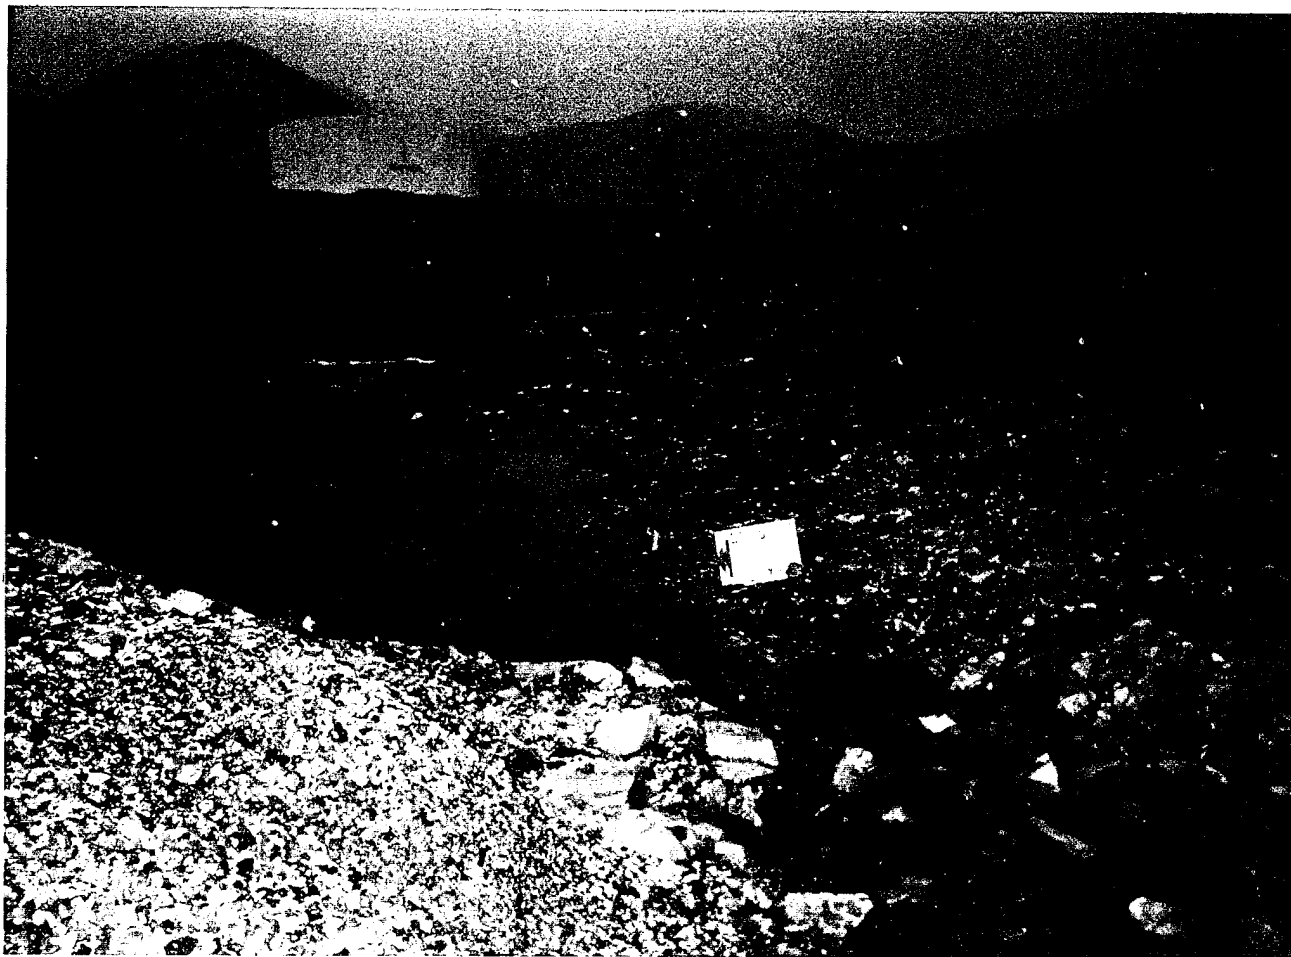
A view to the south of the Spill/Leak #3 (ST07) site located in the lower camp. Leaks from the diesel tanks (upper left) have migrated to the hillside below the tank. In 1994 an interception trench and water treatment system were constructed at the base of the hillside to collect and treat any diesel migrating from the site.

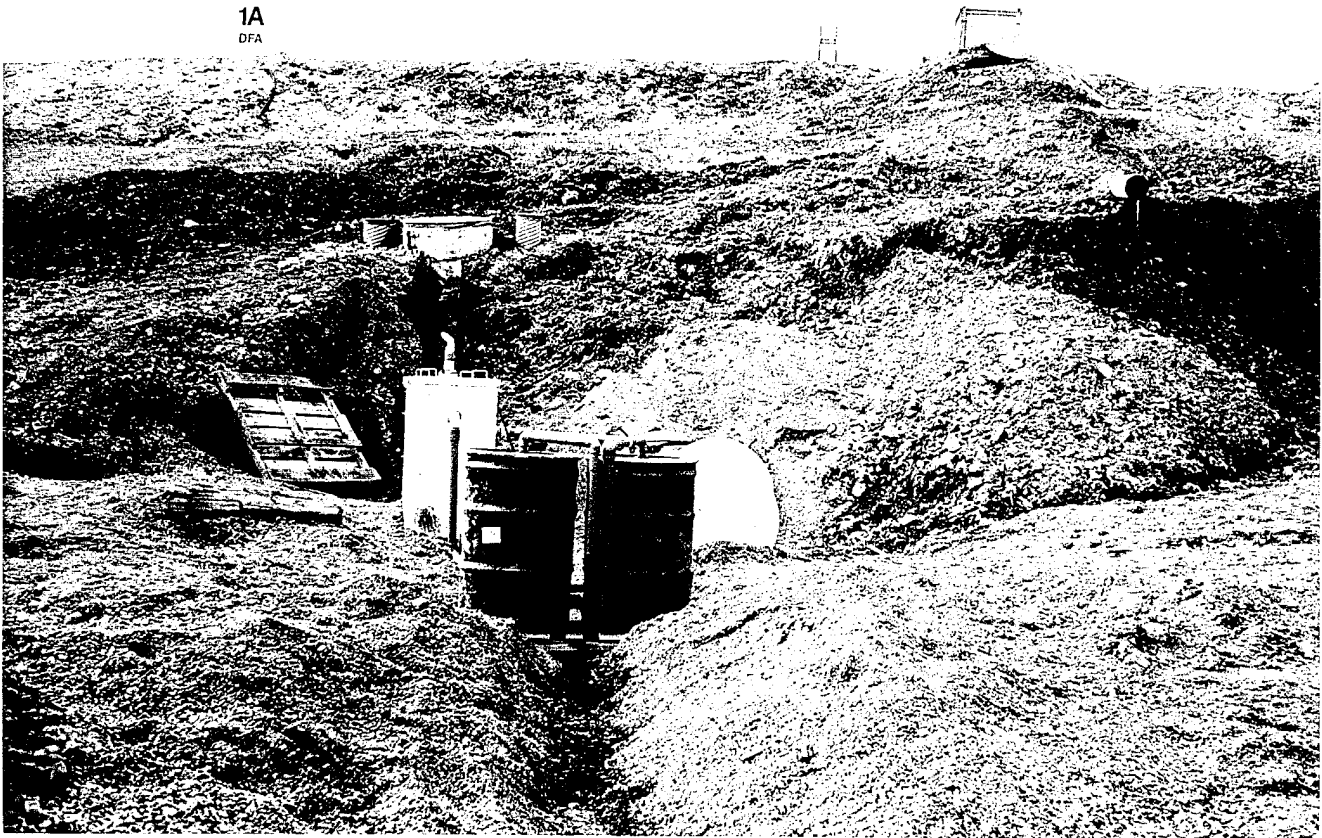
The treatment system at the Spill/Leak #3 (ST07) site consists of an oil/water separator to remove diesel product and carbon adsorption units for treating water collected by the system.

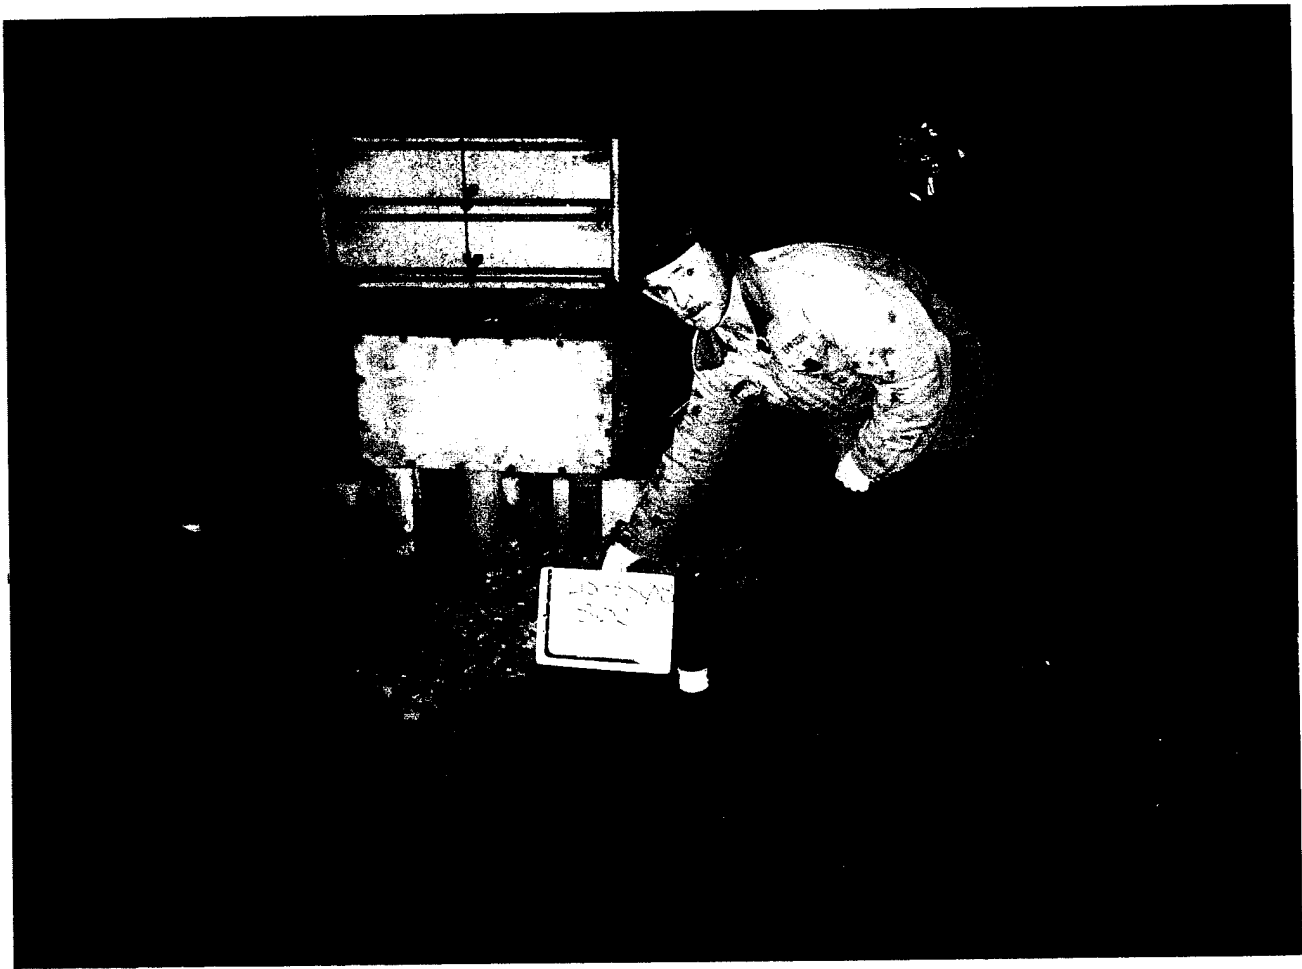
Samples were collected from the soils around the concrete pad at the Upper Camp Transformer Building (SS08) site. This view is of the southeast corner inside the buildings.

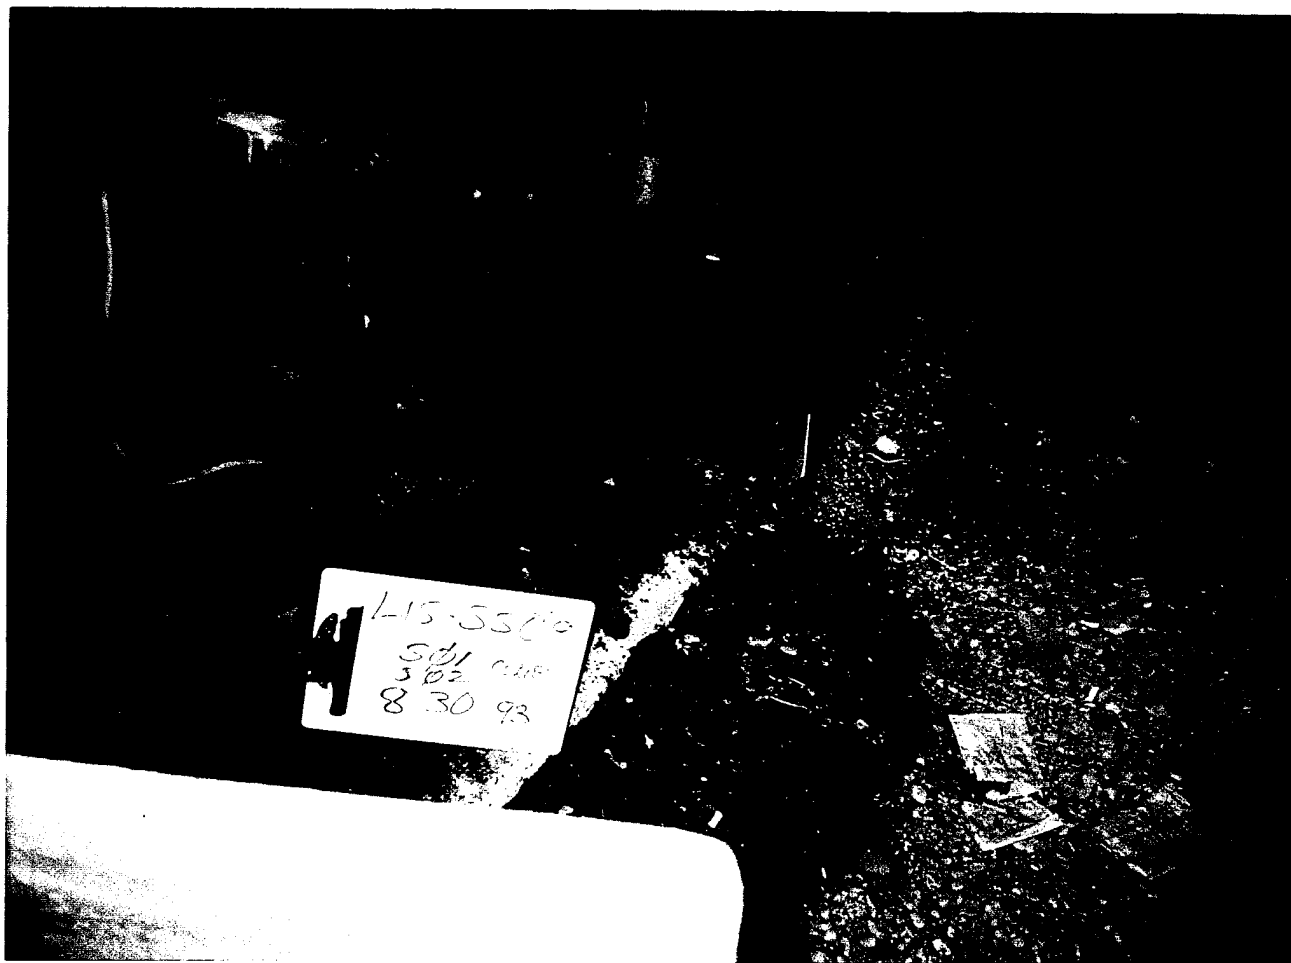
Staining is apparent on the concrete pad and on the adjacent soil inside the Lower Camp Transformer Buildings (SS09) site.

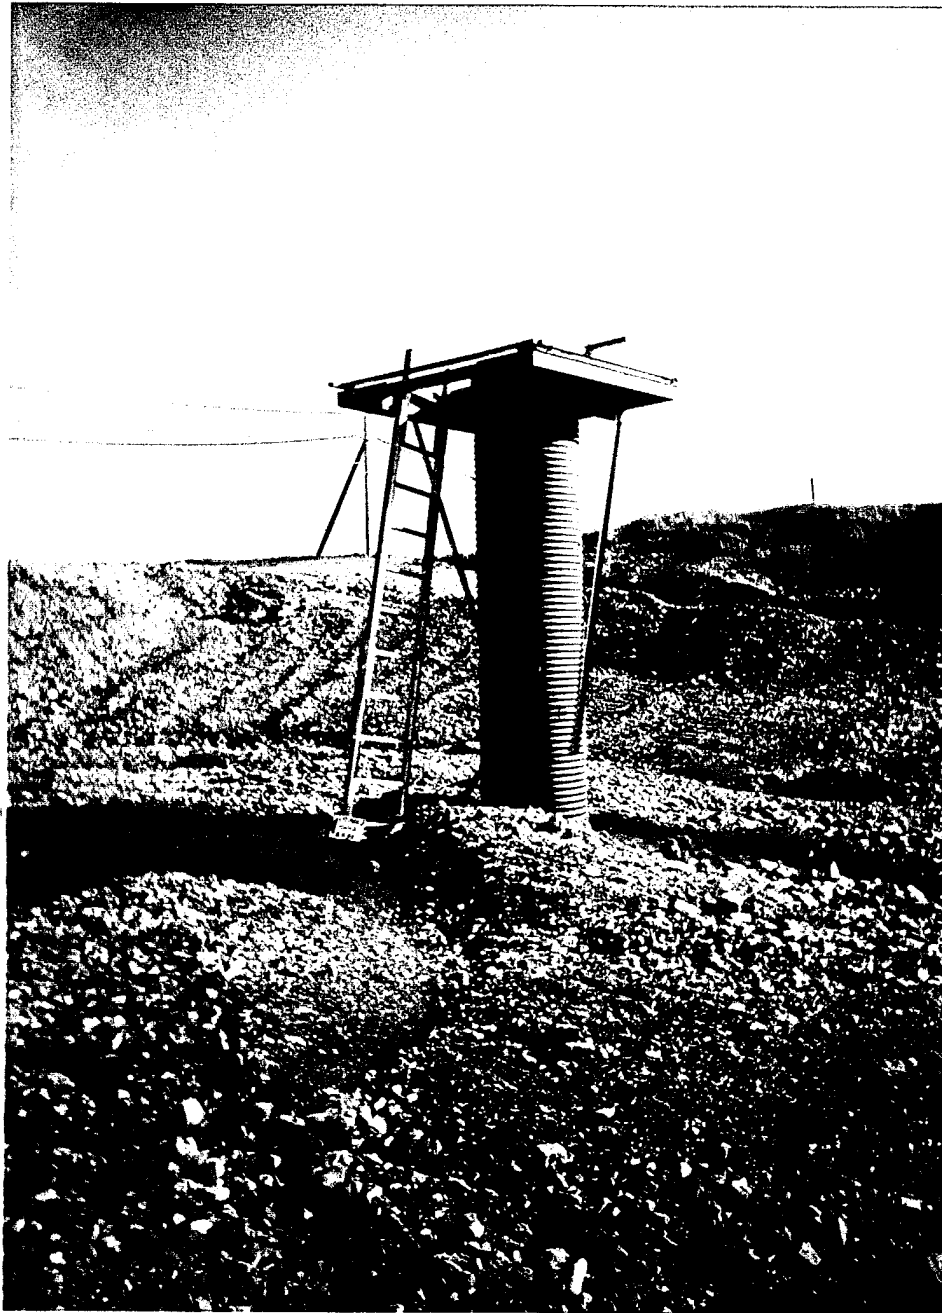
This standpipe located at Selin Creek is part of the Water Gallery (AOC3). This view is to the northeast.
